Restoration Specific Asbestos Survey Report

**4045 Dolphin Circle
Colorado Springs, CO 80918**

**Anderson Property Inspections
Colorado Springs, CO**

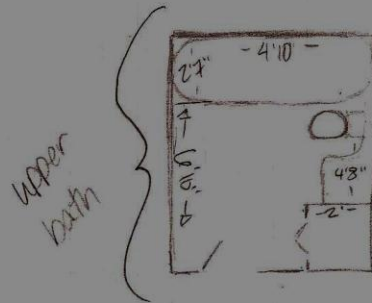
A4045(1-3) - Homogenous
peel textured sheet
rock walls present
as the wall material
in both upper & garden
level baths of this
single family home.
